# Manhole Inspection Summary

Manhole # S31I1016MH

Insp Date: **3/20/07 12:55 PM**

**Location** Address: **201 RIDGEMEDE RD**

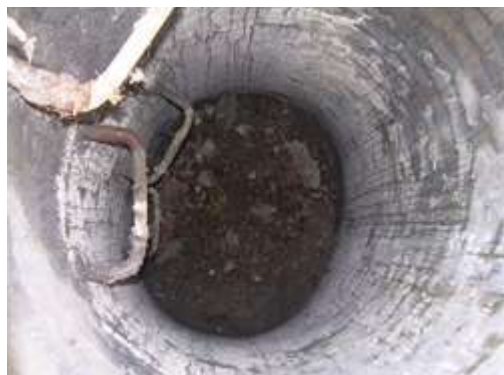
Top View

☒ **Debris** (not Condition related)

Count: **6** Missing: **0** ☒ **Corroded**

Corroded steps. Channel debris.

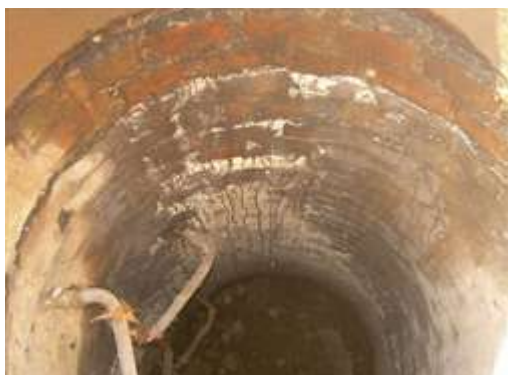
Defect

☒ **Leaks**

Infiltration: ☐ None ☒ **Joint** ☐ Cracks ☐ Mortar ☐ Roots ☒ **Wall**

Infiltration: ☐ None ☐ Joint ☐ Cracks ☒ **Mortar** ☐ Roots ☒ **Wall**

Frame leaks. Adjustment and Corbel infiltration.

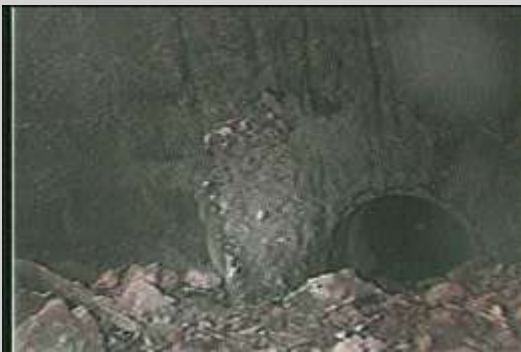
8 in. Circular Gravity Sewer  
Pipe Out @ 12 O'Clock

Deposits: ☐ None ☒ **Mud** ☐ Sludge ☒ **Debris** ☐ Grease

Silt Depth: **3** (in.) Deposits Extent: **Medium**
